DRC Home Inspections

Home Inspection Report

123 Your Street, Woodstock, IL 60098
Inspection prepared for: John Doe
Date of Inspection: 11/8/2016

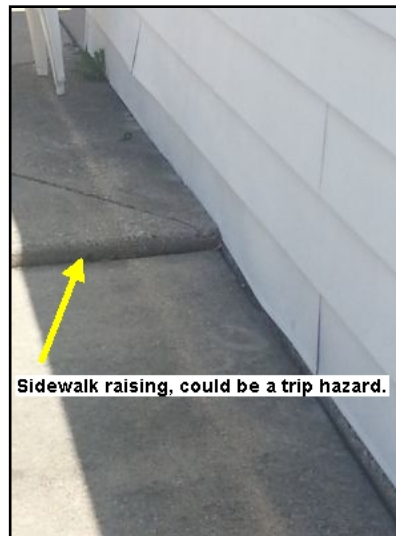
- ****Driveway****
- Appears in satisfactory and functional condition with no major system safety or function concerns at time of inspection, unless noted..
- ****Sidewalks****
- Potential Trip Hazard(s) at sidewalk; monitor / repair as necessary.

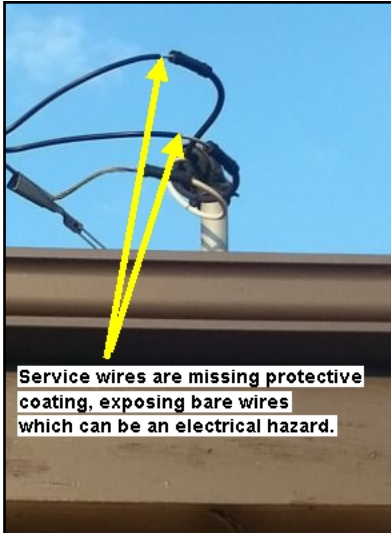
- There is an overhead service drop noted.
- Exposed connection, missing splice cover observed at masthead. Suggest contacting the local electric utility company for repair, as necessary, for safety.

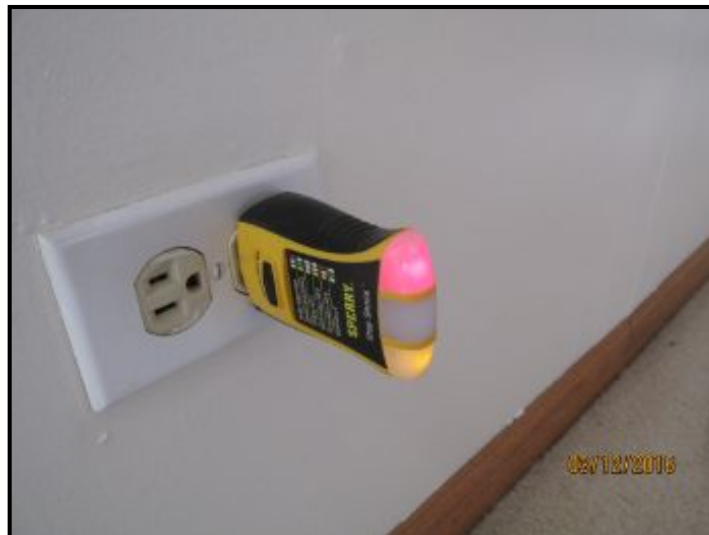
*Open neutral: This means the receptacle is not working properly because, even though the black wire is hot, the white (neutral) wire is not connected well somewhere, so that it cannot carry any current "back" to the main panel.

We recommend that a licensed electrician evaluate, repair and replace wires and connections as necessary.
